DRYRIGHT^{LTD}

SURVEY REPORT	Date: 11 July 2007	Report Number: DR0707111
----------------------	---------------------------	---------------------------------

SITE DETAILS	
Name:	The Storyteller Pub
Address:	Retail World Stadium Way Park Gate Rotherham
Postcode:	S60 1TG
Contact Name:	Martin Nixon
Telephone:	
Mobile:	07836 373949
Email:

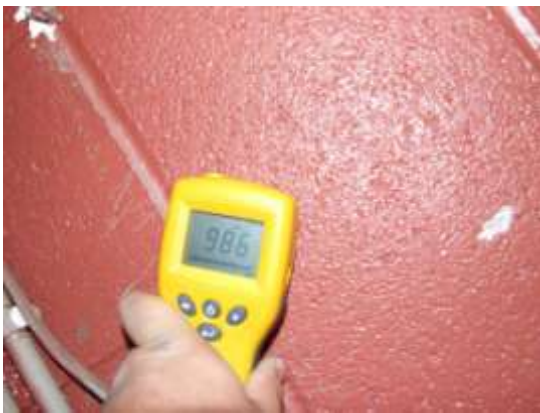
Protimeter reading 98% on interior wall

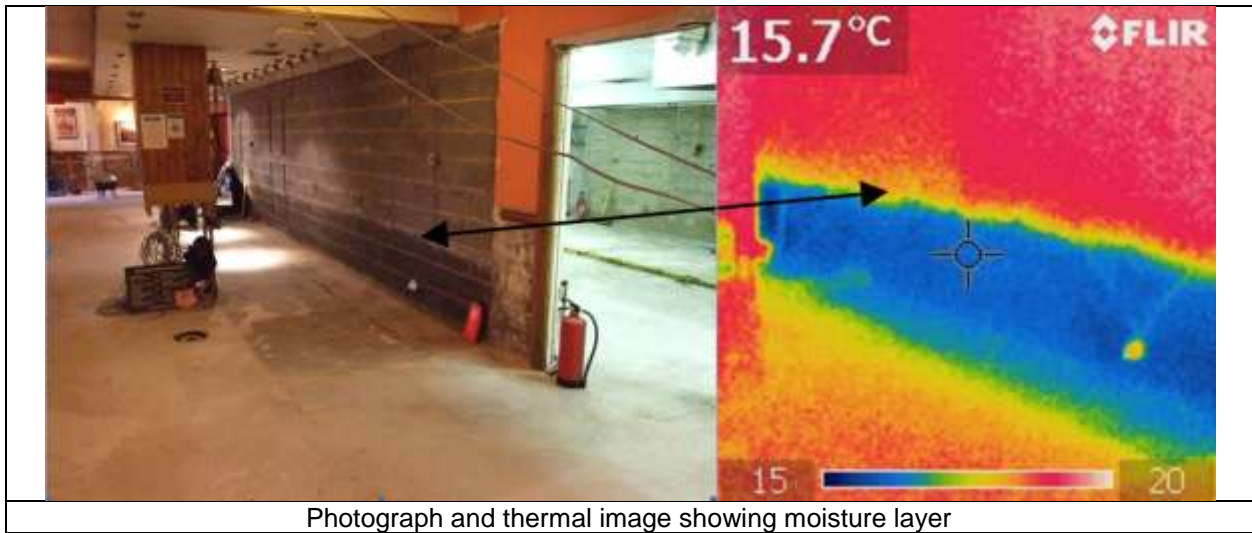
Photograph and thermal image showing moisture layer

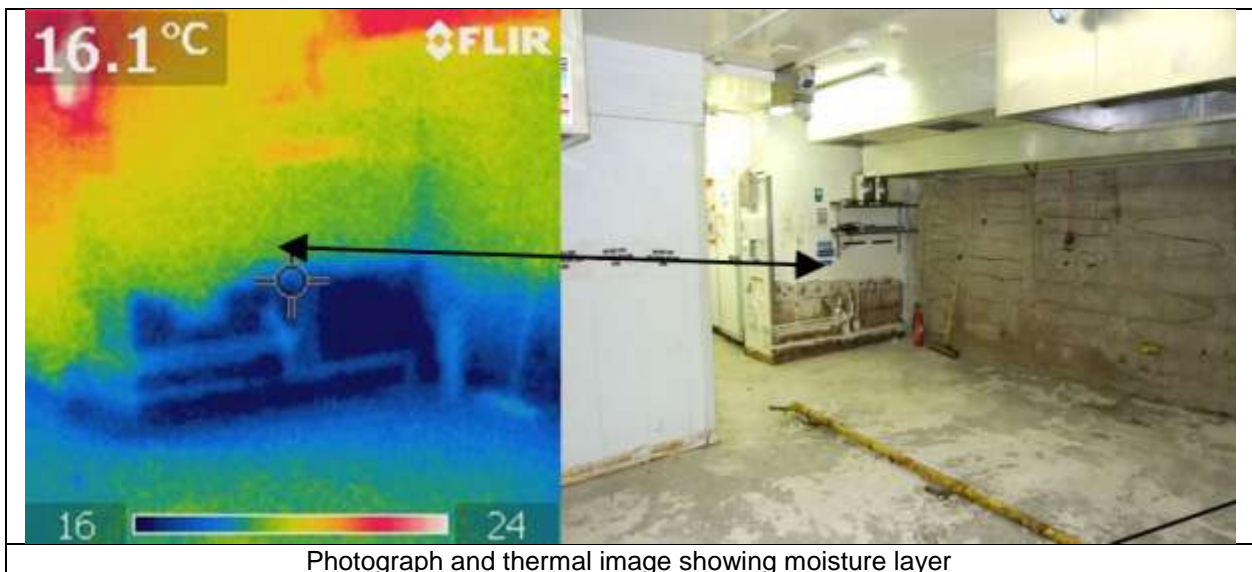
Photograph and thermal image showing moisture layer

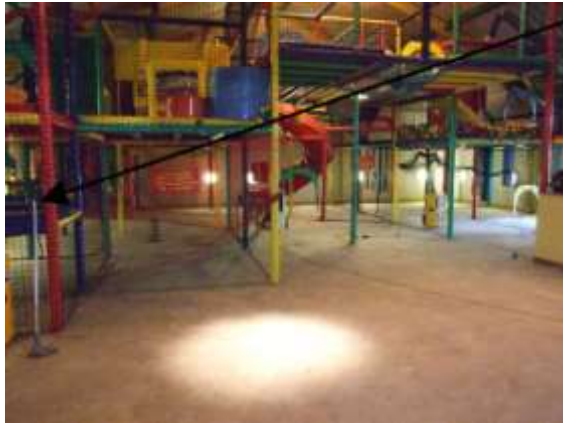
A small area of the soft play area has been coated with waterproof easy clean paint, which needs treatment before drying.

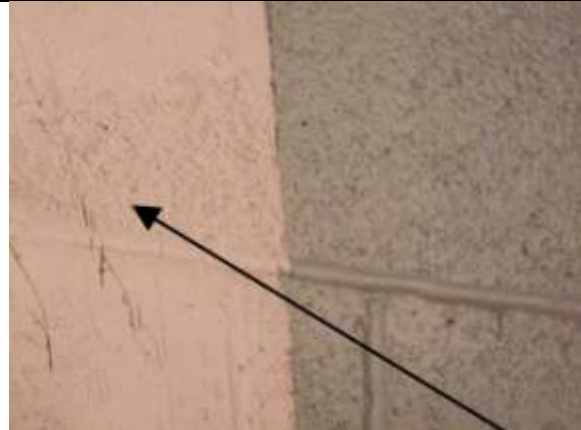
Detail of the problem paint which will need to be scarified before drying.
